Ammonium nitrate induced cracking of a dryer.

R.E.Clegg^{1§}, R.Tomlins² and M.J.Mackay³

Abstract

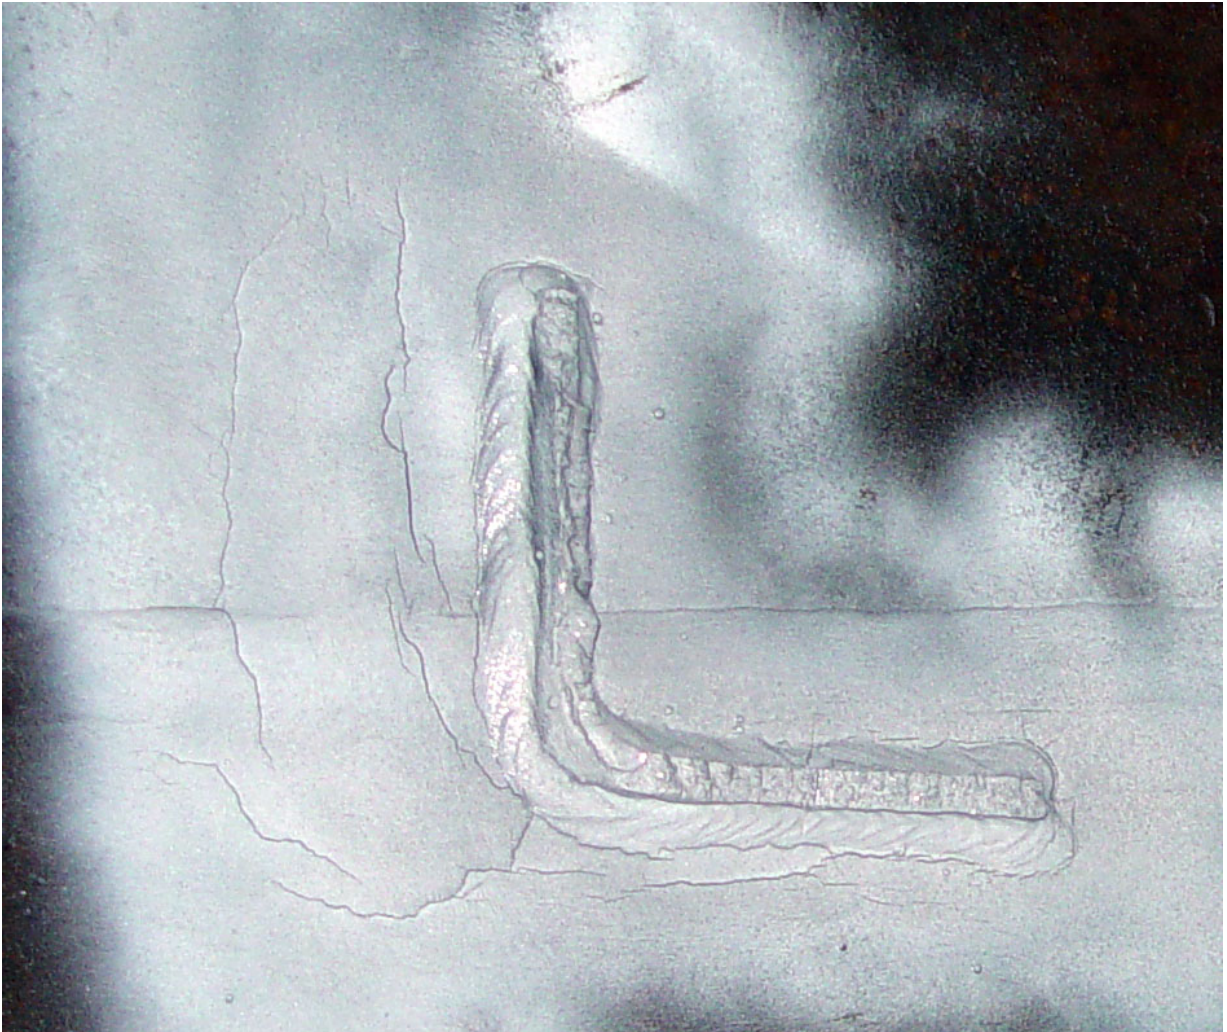
Cracking of the dryer shell was generally associated with welds or in several cases, where welds had been removed. Cracking of the lugs was generally either in the toe of the welds or transverse to the welds (see Figure 1). Cracking was also found associated with the circumferential and longitudinal welds in the shell (see Figure 3). In some cases, the cracks penetrated the thickness of the shell. The cracks were predominantly transverse to the welds and often were confined to the weld metal. However, in a number of cases, the cracks were found predominantly in the parent plate.

Figure 1 Extensive cracking around the welded lugs and in the welds could be seen on the inside of the shell.

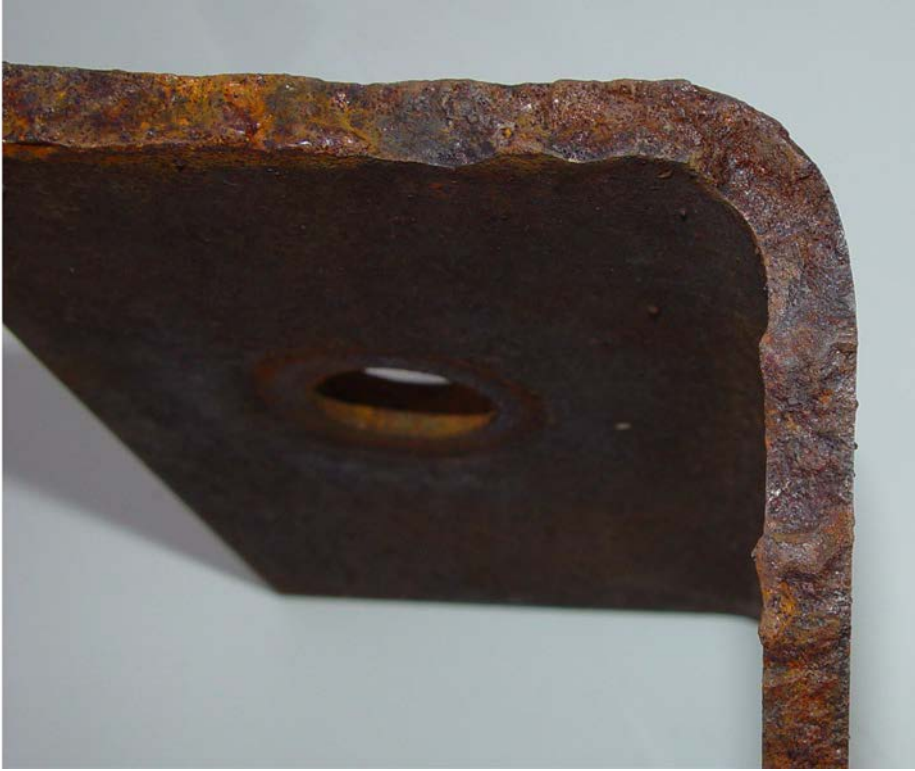
Each of the internal lifters was attached to the shell by bolting to two welded lugs. In a number of cases, these lugs had fractured through the heat affected zones of the welds. Failure of the lugs had occurred in the region of the welds, predominantly in the HAZ (see Figure 2). The

fracture showed little ductility, although it was covered with a layer of corrosion product. The fracture did not appear to be a fatigue failure and the fracture surface was textured in a manner consistent with stress corrosion cracking.

Figure 2 Lifter showing the cracked lugs. These lugs had been welded to the shell and had fractured through the HAZ of the weld.

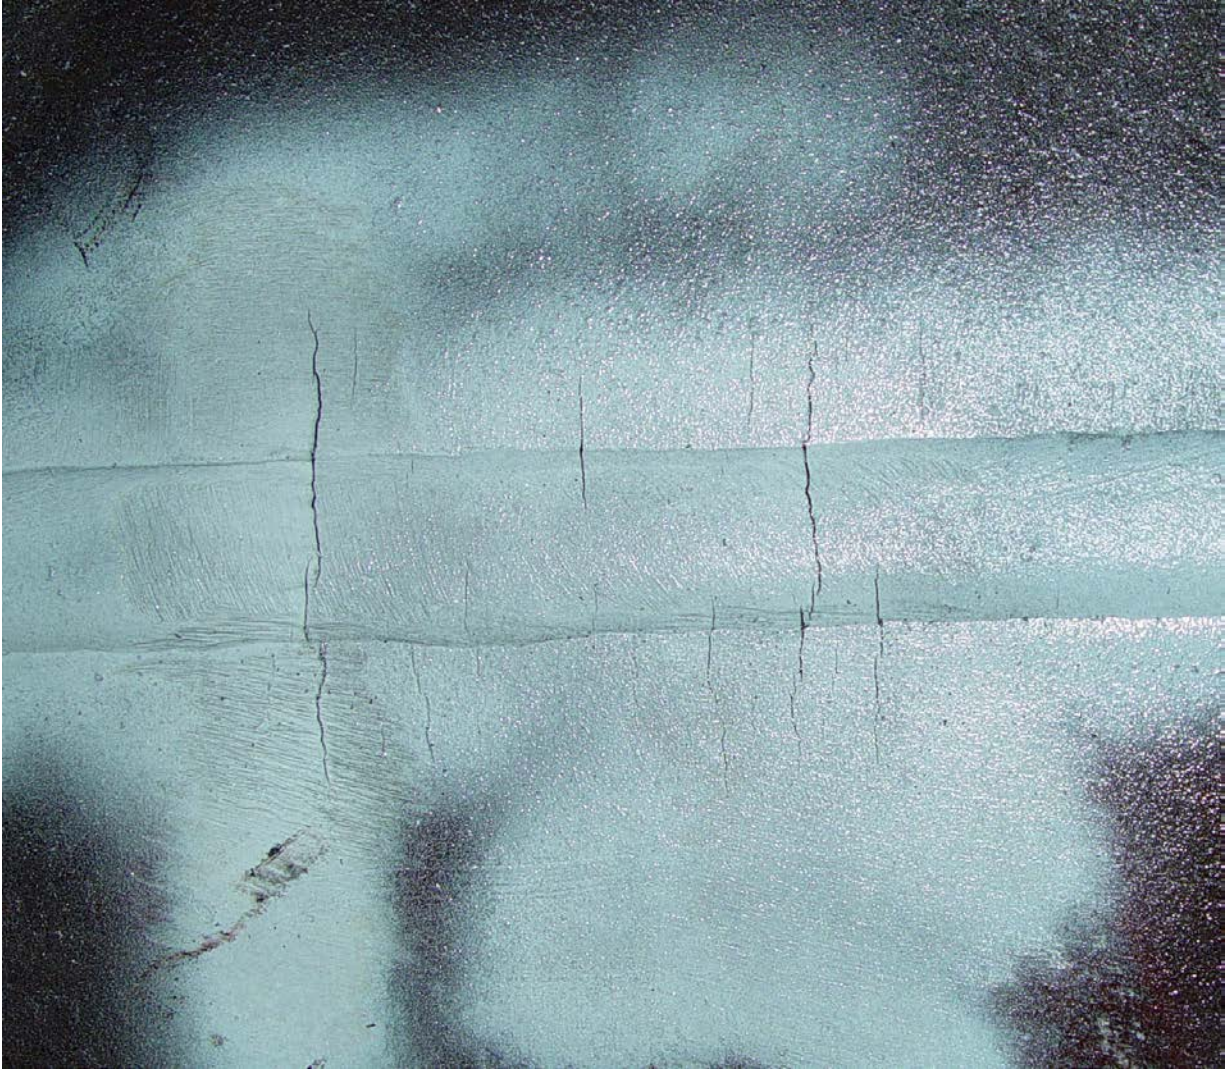
Figure 3 Transverse cracking in seam welds.

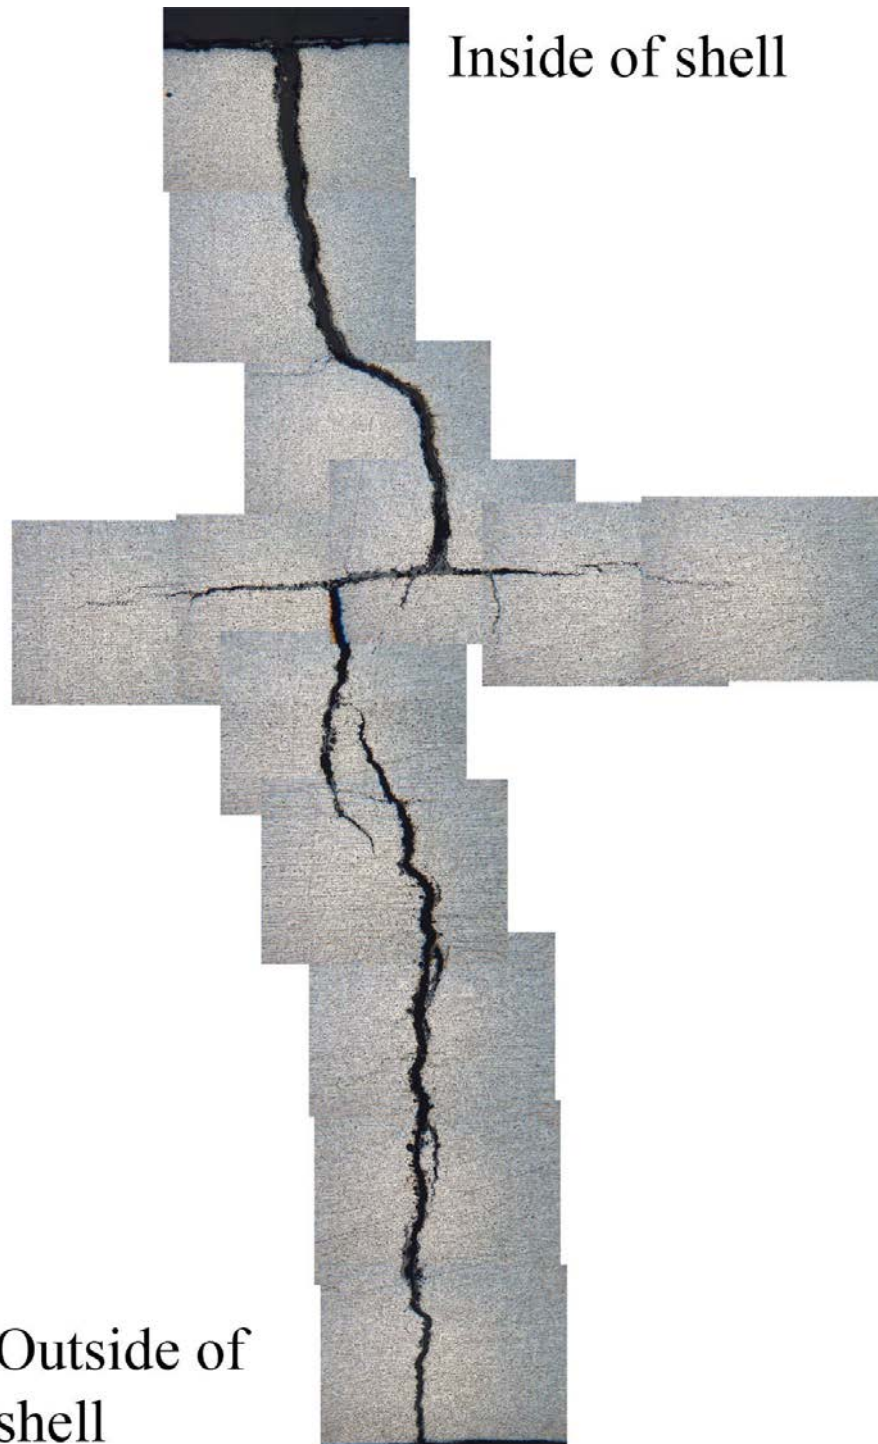
The parent plate consisted of pearlite and ferrite. In the section examined, the crack had penetrated from the inside surface of the shell to the outside surface. In places the crack had branched and ran parallel to the plane of the plate. This was particularly noticeable near the centreline of the plate. Cracking was generally intergranular in nature and were commonly

filled with oxide. A number of fine intergranular cracks could be seen propagating from the inside surface of the shell (Figure 4). The inside surface also showed evidence of general corrosion and some intergranular attack (Figure 5).

Figure 4 Cracking of the shell occurred from the inside to the outside of the shell. Significant centreline cracking was observed.

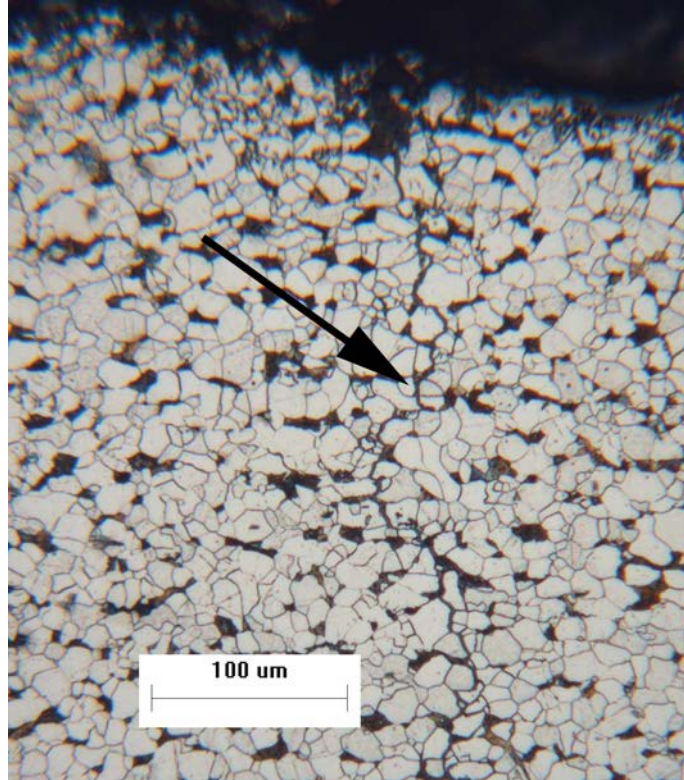
Figure 5 Small crack coming from the surface of the steel plate.
